A Contractor You Can Depend On

SPS delivers as promised at Quail Run

The Villages at Quail Run Hudson, Mass. 2011

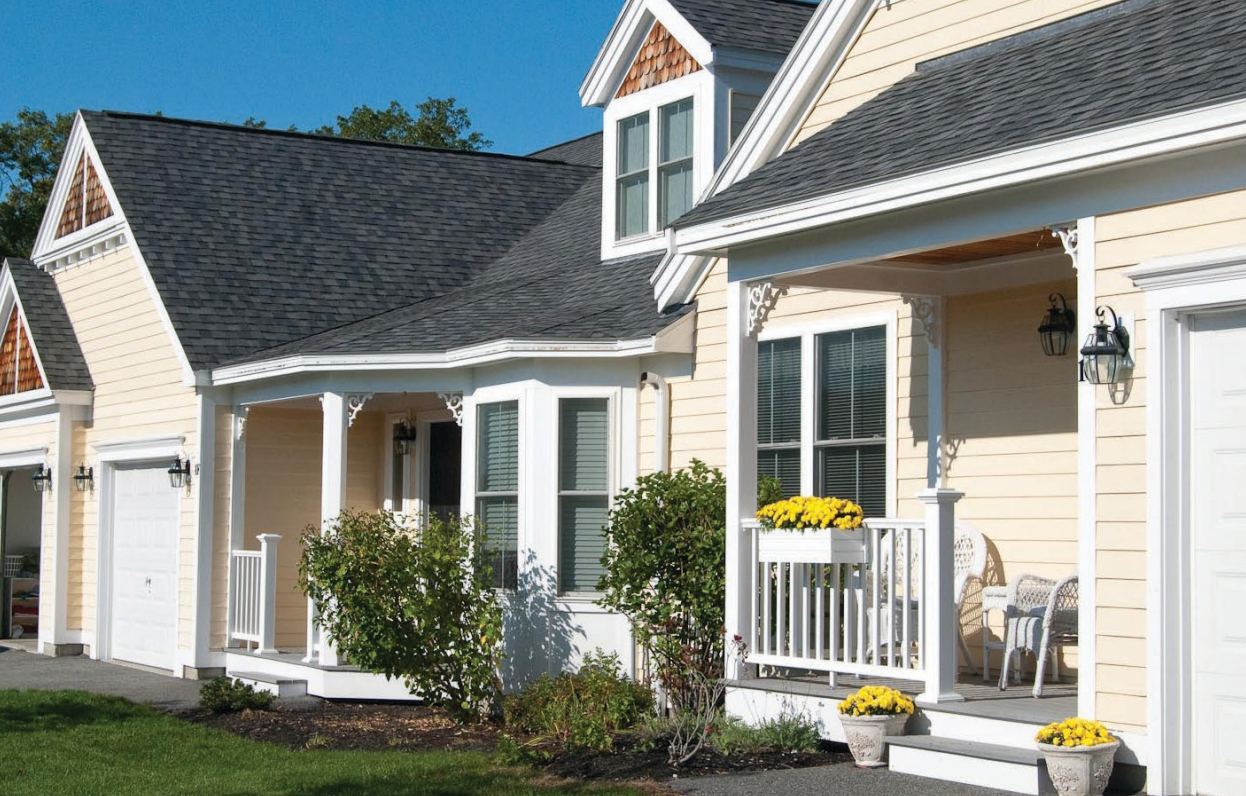
Schernecker Property Services completed Quail Run's multi-million dollar roofing project on time thanks to expert project management and SPS's focus on large-scale exterior work for the condo market.

Accordingly, the scope of work for Quail Run's roofing replacement called for SPS to install ventilation baffles at the eaves and to remove construction barriers in the attics to allow unrestricted airflow from soffit to ridge vents. Extra exhaust vents were also added in some areas.

To guard against leaks, waterproofing membrane was installed over the entire front porch roof deck and nine feet above the transition to the main roof. Nine feet of membrane was also installed along the edge of the rear roofs and in the valleys. In order to install proper flashings, SPS removed and replaced most of the above-roof fiber cement siding and PVC trim boards. All dormers were also reflashed.
